2020 Peacock Gap Lagoon
Annual Water Quality Report

Appendix A
June 9 2020 Water Quality Assessment

RE: Water Quality Assessment – Peacock Gap Lagoon

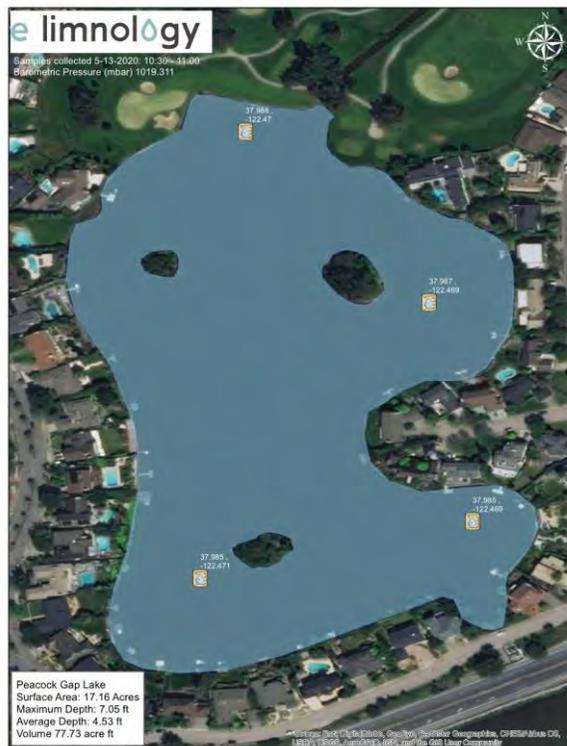
Figure 1 PGL WQ sample locations

Pursuant to a request for lagoon management services, water quality monitoring of Peacock Gap Lagoon began in July 2020. Monthly monitoring was performed (ending in October '20) the 2021 management season runs from March - October. In addition to sedimentation management, water samples were also collected periodically during this time to gain a better understanding of the nutrient concentrations, specifically related to total phosphorous and total kjeldahl nitrogen (TKN). The data acquired will help set a baseline to compare future samples and measurements to and be useful to evaluate the effectiveness of ongoing and future management strategies. Monthly water quality data sheets were submitted for review throughout the monitoring season. The sample sites are located on the map below. The '20 monthly water quality updates can be found in Appendix B of this report.

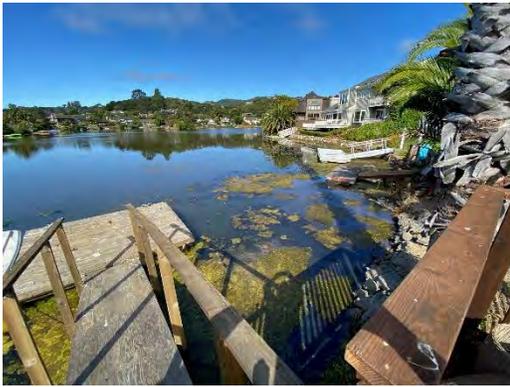
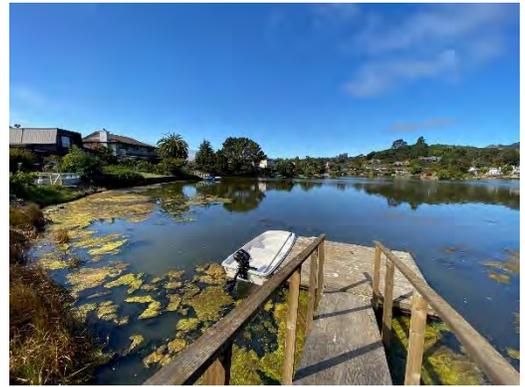
Figure 1 PGL aeration location 8/2020

Monthly monitoring did reveal that DO concentrations increased across the lagoon, however the data does not suggest this can be attributed solely to the nanobubbler. Continued monitoring will reveal the extent to which the single unit is affecting the entire lagoon. Particular attention should be paid to the field measurements of Oxidation Reduction Potential (ORP) which is a more direct measure of the presence of nanobubbles and their oxidative effect. Monthly water quality summary sheets (Appendix B) show the positive increase in levels that will aid the lagoon in returning to a healthy body of water supporting marine life and minimizing unwanted levels of aquatic vegetation. Below are pictures taken prior to, and approximately 8 weeks post oxygenation system commissioning.

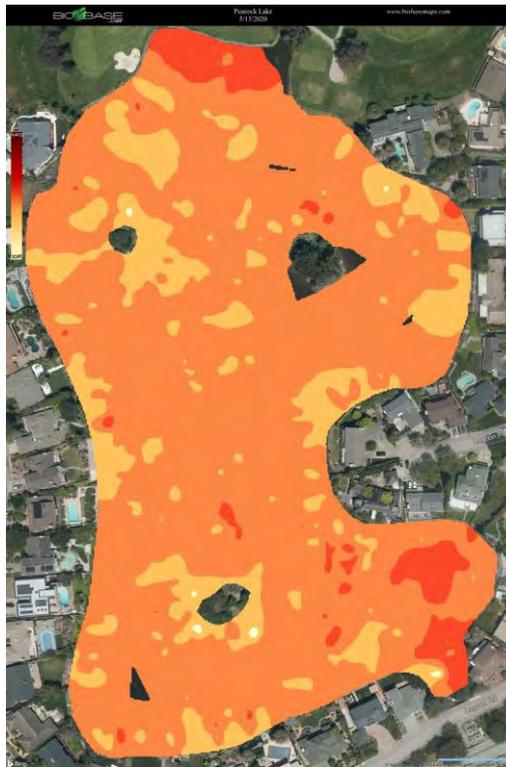
Figure 5 Bio Density (Hard Pan) Mapping

A beneficial bacteria product called Muckbiotics was introduced to the lagoon on a monthly basis beginning in July. This product is designed to saturate the surface of the sediment layer with rare earth stimulants and a broad spectrum of natural bacterial cultures. This establishes a healthy microbiota at the water-to-sediment interface that accelerates the digestion of organic matter. The microbiota functions as a biofilter, reducing harmful nutrient loading from both internal and external sources. Evaluation of the sediment layer in 2021 will reveal the effectiveness of this product in the lagoon and adjustments will be made to the application rates and areas treated accordingly. Below is a map of the lagoon sea floor hardness. Lighter in color indicates higher volume of Bio mass/Bio sedimentation.

No BMPs for erosion or runoff were performed in 2020 and is recommended to continue monitoring. Special attention should be paid to the creek inlet in the north entering the lagoon from the golf course. It is still a recommendation that a combination of BMPs such as silt screens, check dams, bio-swales or a sediment deposition basin should be considered to address this source of sediment. In addition, stabilizing unprotected shorelines around the islands and along the golf course should be addressed.

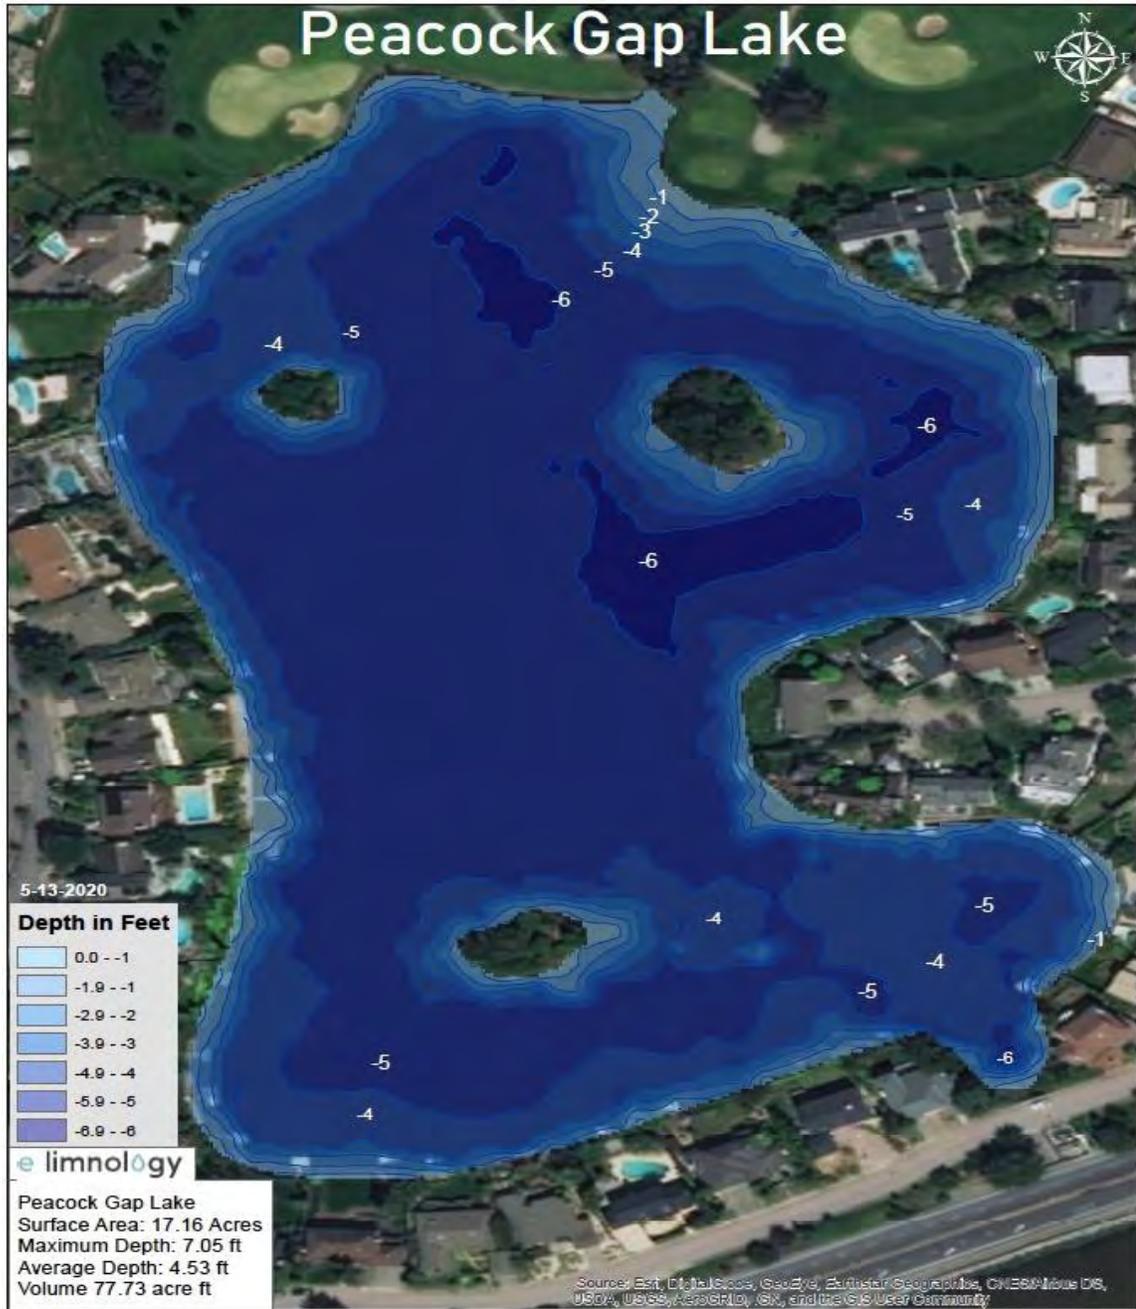
Figure 1 Peacock Gap Lagoon Bathymetric Mapping

The Lagoon is approximately 17 acres with a maximum depth of approximately 7 feet and an average depth of 4.5 feet (Figure 1). Salinity in the water column ranged from 18 PSU (Practical Salinity Unit) near the bottom, similar to San Francisco Bay (Bay), to 9 PSU at the surface. This gradient was likely a result of a light rain event the previous day that temporarily stratified the water due to differing water density (i.e., salt water is more dense). It is likely that the salinity of this system is more homogeneous throughout the Lagoon and mimics that of the Bay more closely. The salinity of similar muted, tidally-influenced lagoon systems in the region tend to fluctuate seasonally, with runoff during the rainy season, and mimic the salinity of the Bay in summer, with water exchange being a common management practice to control temperatures and surface water elevation.

The Lagoon's water temperature was approximately 18 degrees Celsius (°C) with little variation at depth (17.9°C to 18.9°C), and dissolved oxygen (DO) levels were high at the surface (9 milligrams per liter [mg/L], greater than (>) 100% saturation), and dropping below optimal conditions by around 4 feet of depth (below 4 mg/L). Anoxic conditions were present at the very bottom of the Lagoon. Visibility of the water was also poor below depths of 1 foot throughout the Lagoon.

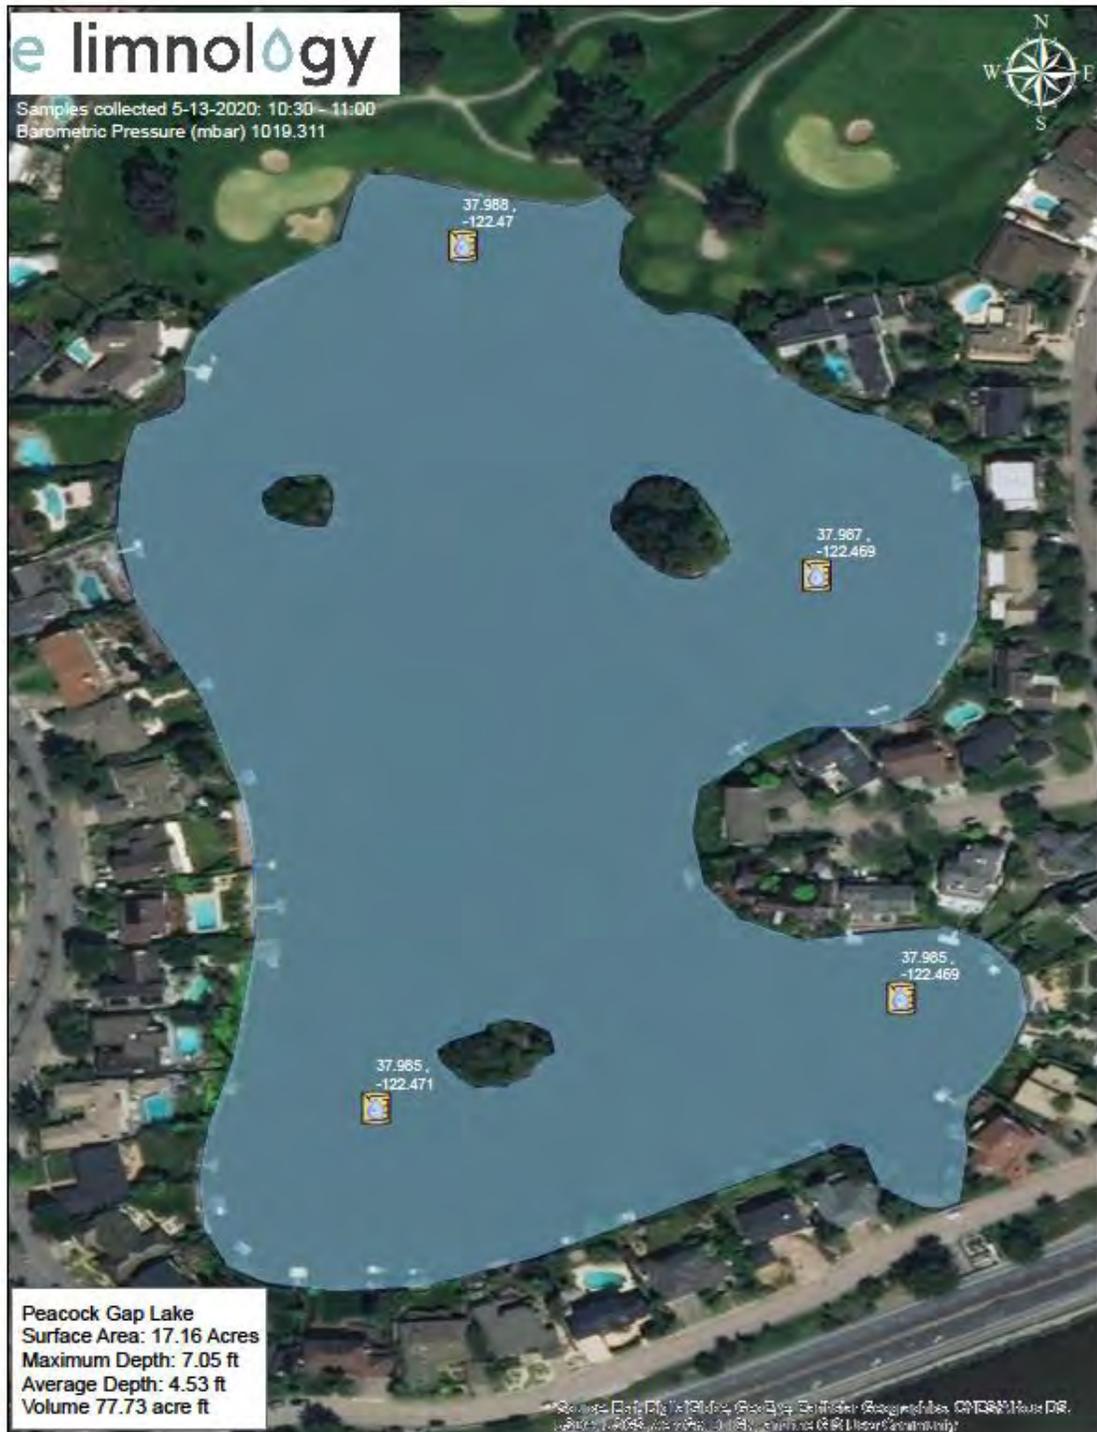
Figure 2 Peacock Gap Lagoon Sample Locations

Based on the overall size of the Lagoon, four sample sites were selected (Figure 2). Abundant algae was present, especially in the southeast cove. There were mats of Filamentous Cyanobacteria consisting of Lyngbya and Oscillatoria (Figure 3). Only one species of aquatic plant was collected, horned pondweed (*Zannichellia palustris*,

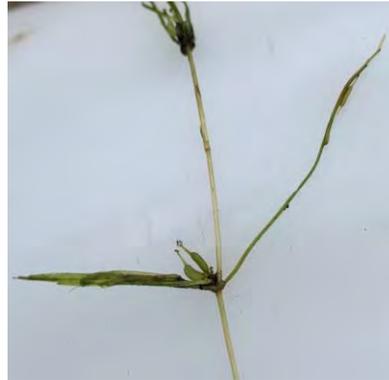
Figure 4 Zannichellia palustris

Figure 4), although it is likely that Wideon grass (*Ruppia maritima*), which is common in brackish water in this region, is also present.

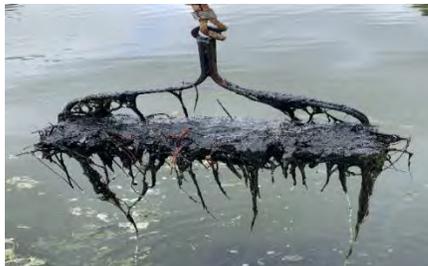
Figure 3 Organic sedimentation found on the lagoon floor

The sediment was anoxic, black in color, and odorous with abundant detritus. Rake samples revealed a high percentage of leaves that were not decomposed (primarily pine needles and some deciduous leaves), as well as a lot of what appeared to be coiled calcareous tubes, likely from a species of tube worm (*Serpulidae sp.*). Biomass accumulation appears to be heavily concentrated at the northerly end of the Lagoon, adjacent to the golf course, and the southeast corner cove, where the pump system is located (Figure 7).

Sediment management recommendations consist of deploying beneficial bacteria and enzymes. There is no permitting and/or reporting to local and state regulatory agencies for applying bacteria/enzyme tablets into the Lagoon. Additionally, this product is not harmful to humans or animals.

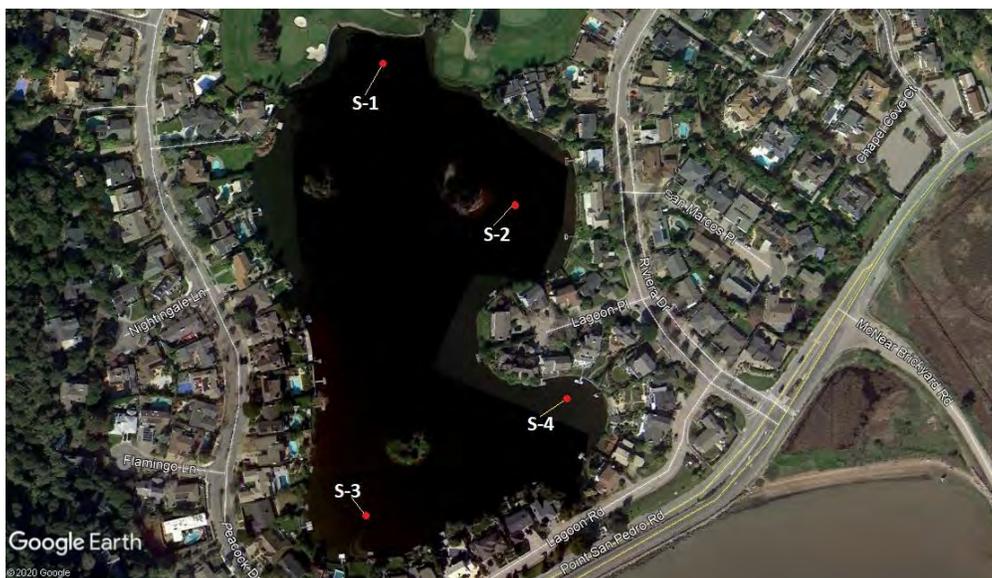
SURFACE	SEAFLOOR
Temp:	66	66.1
pH:	8.29	8.39
NTU:	3.2	3.99
DO mg/l:	9.22	2.9
Sal:	9	14
Depth:	1.3	5.4

Summary: Please refer to the PGL Assessment dated 7/9/20
 Note significant difference in Salinity and DO from surface to seafloor

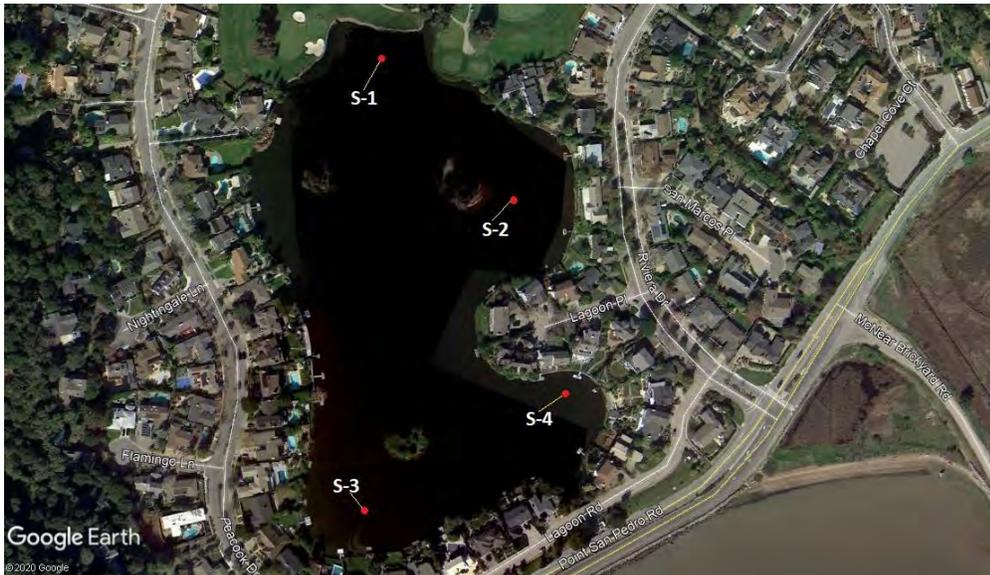
SURFACE	SEAFLOOR
Temp:	75.4	75.2
pH:	8.3	8.39
NTU:	4.4	4.7
DO mg/l:	2.7	2.77
Sal:	24.1	24.2
Depth:	1.3	5.4

Summary: Dissolved oxygen levels are lower than our initial readings in May as a result of vegetation growth. Salinity has risen to comparable levels with the Bay, Blue Green algae levels are 6-10mg/l (low) and Chlorophyll level is 9-10 mg/l (mid). Lab samples indicate both Total Nitrogen and Phosphorus are 2-3 times higher than minimal level for algae to populate. Nitrogen levels should drop with the enzyme applications, Phosphorus levels should drop once the Nano bubbler system is up and running. July 2020 score 3.5/10

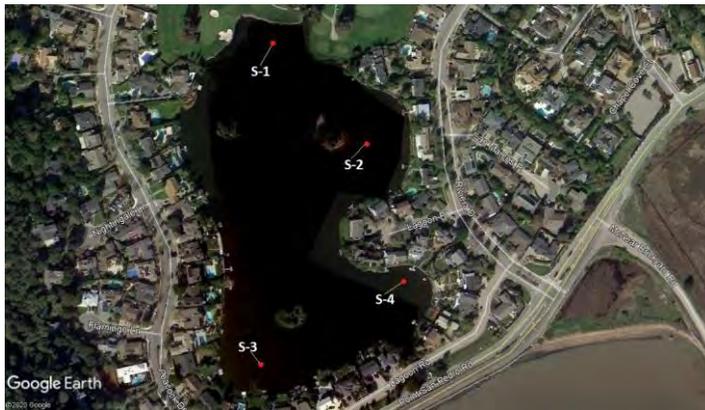
SURFACE		SEAFLOOR	
Temp:	74.4	Temp:	74.8
pH:	8.2	pH:	8.1
NTU:	17.7	NTU:	20.9
DO mg/l:	7.8	DO mg/l:	4.3
Sal:	25	Sal:	24.9
Depth:	1.4	Depth:	4.5

Summary: Molear Nano bubbler installed near S-4 on August 15th and started to show positive signs on the adjacent algae mats almost instantly. The August monitoring took place approximately 10 days after installation. Improvements to the DO levels near the unit are evident. Turbidity level are higher this month indicating the Muck Biotocs are working to consume biomass at the seafloor. August 2020 lagoon score: 4.50

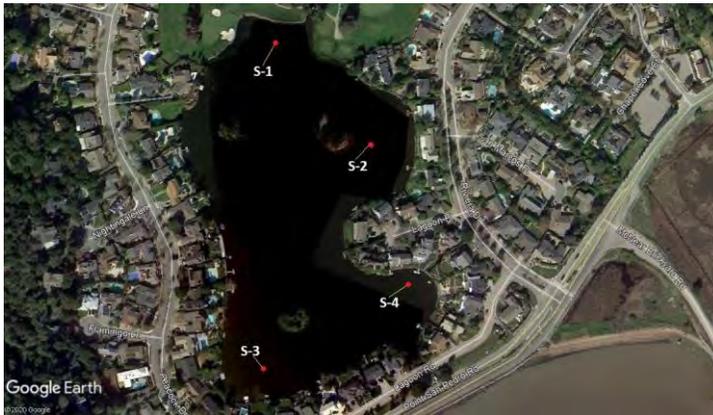
SURFACE		SEAFLOOR	
Temp:	70.1	Temp:	71.9
pH:	7.5	pH:	7.6
NTU:	22.3	NTU:	28.9
DO mg/l:	7.7	DO mg/l:	5.5
Sal:	23	Sal:	27.1
Depth:	0.6	Depth:	5.1

Summary: Molear Nano bubbler installed near S-4 on August 15th, 90% of existing visible Algae mats have diminished without signs of repopulation. DO levels have increased significantly throughout the lagoon, Visible marine life (Fish) appear to be reacting to the increase in oxygen. Turbidity level are higher this month indicating the Muck Biotocs are working to consume biomass at the seafloor Lagoon is currently going through it's annular turn indicated by the temp inversion. pH levels have returned to neutral September 2020 Lagoon WQ Score: 7.0

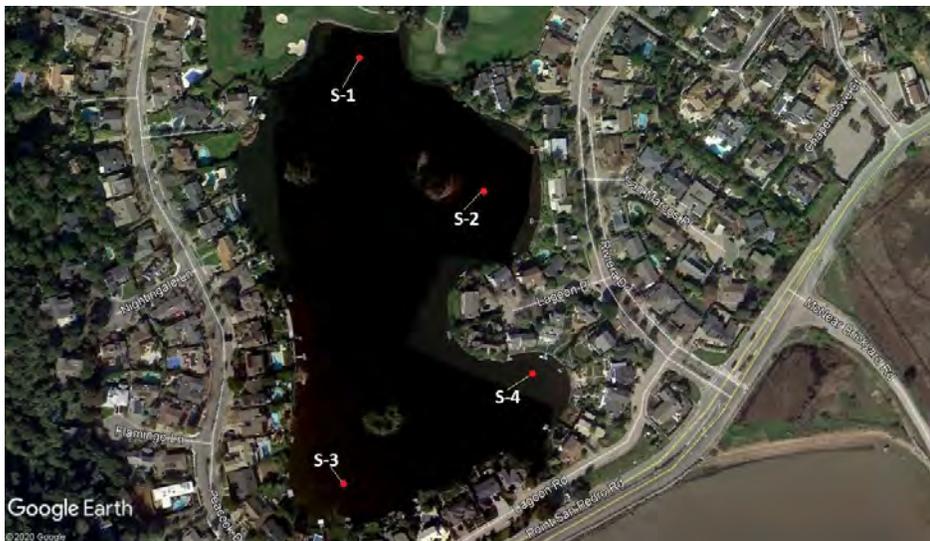
SURFACE	SEAFLOOR
Temp:	68	67.2
pH:	8	8
NTU:	14	12
DO mg/l:	7.2	5.5
Sal:	27	27.2
Depth:	1.3	4.6

Summary: Dissolved oxygen levels continue to rise with the introduction of the nano bubbler Salinity has risen to comparable levels with the Bay, Nitrogen (TKN) level is high, Recommend Nitrogen source sampling No visible sign of Algae along shoreline, Clarity has increased due to Muckbiotics. Monthly Lagoon Score 8.5/10
